AGENDA

Red Run Intercounty Drain Drainage Board Macomb and Oakland Counties

December 17, 2025 – 10:30 a.m.

Summary of Site Visit: *[Summarize pertinent discussions with sponsor regarding levee conditions, O&M activities, etc. and describe notable observations or changed conditions since the last site visit or inspection]*

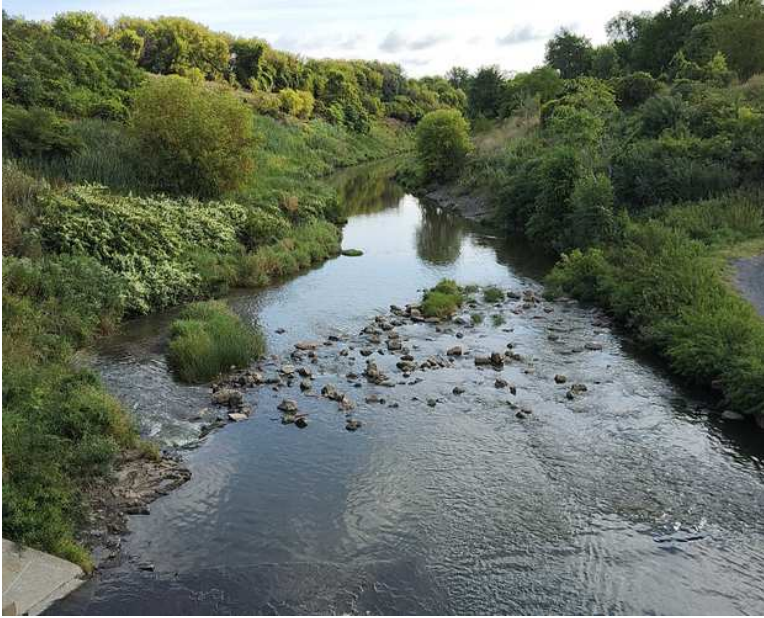
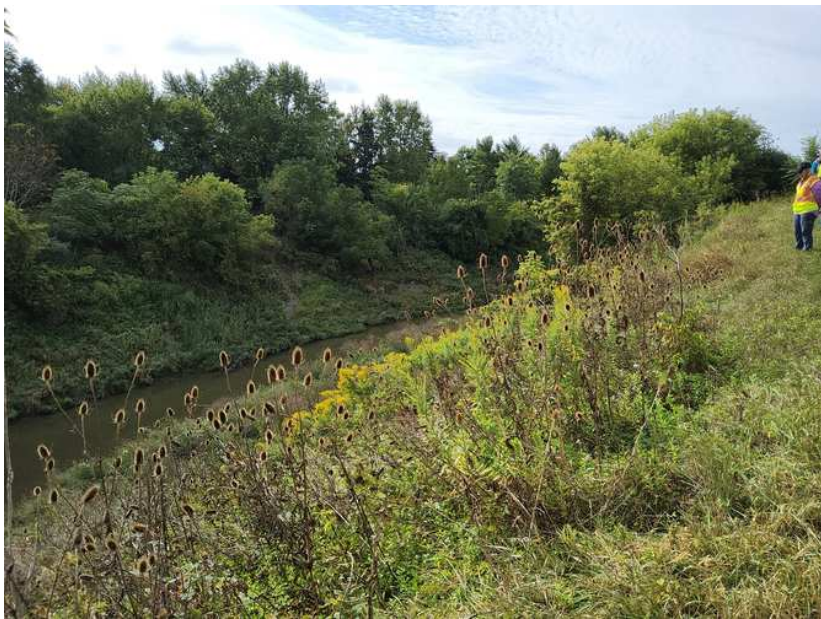
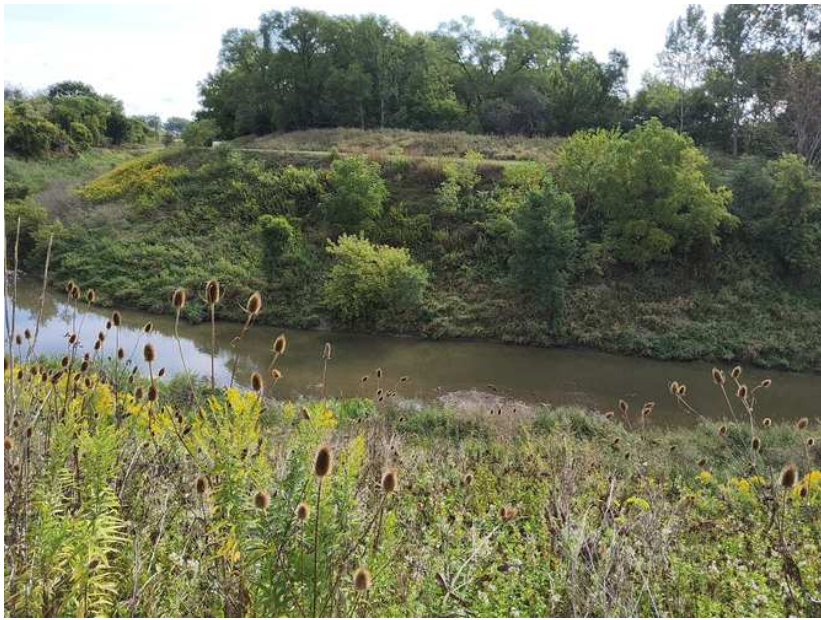
Inspect ID: 2025-10000

10000 - Bank conditions downstream of the George W. Kuhn (GWK) Drain at the upstream limit of project.

Full Observation Number		2025-10000		Category		FRM Channels	
Rated Item		Vegetation and Obstructions		Location		Other	
Description of Observation		Bank conditions downstream of the George W. Kuhn (GWK) Drain at the upstream limit of project.					
Photo Count							
Status		Typical Conditions		Observation Type		Point	
Station Start				Station End			
Latitude Start	42.52410	Latitude End		Longitude Start	-83.08659	Longitude End	
Observation Date	2025-09-04

Observation Number	10000
Observation Year	2025
Full Observation Number	2025-10000
Reinspected? (Y/N)	N
Original Observation Number	
Feature	FRM Channels
Rated Item	Vegetation and Obstructions
Rating Code	
Rating Description	
Location	Other
Status	Typical Conditions
Monitor (Y/N)	Y
Observation Type	Point
Station Start	
Station End	
GPS Start	(42.5241, -83.0866)
GPS End	
Latitude Start	42.5241
Latitude End	
Longitude Start	-83.0866
Longitude End	
Observation Date	9/4/2025
Description of Observation	Bank conditions downstream of the George W. Kuhn (GWK) Drain at the upstream limit of project.
Number of Photos	undefined

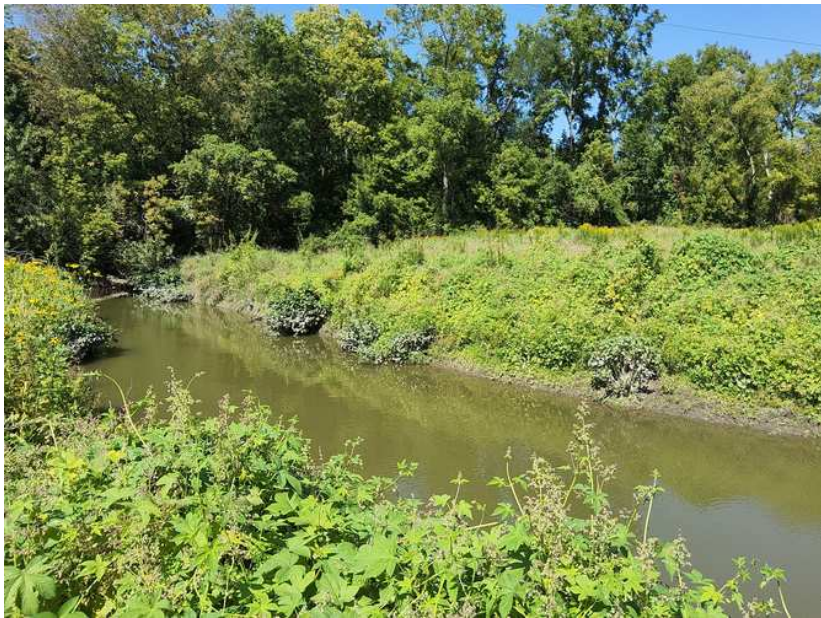
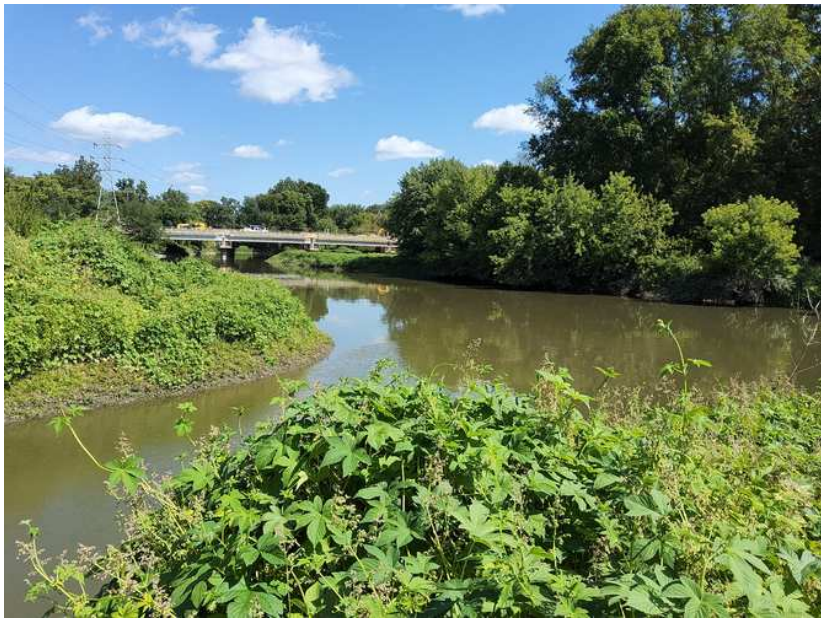
Inspect ID: 2025-10012

10012 - Location of confluence with Plum Brook. Macomb County mentioned there is a hydraulic drop after the confluence.

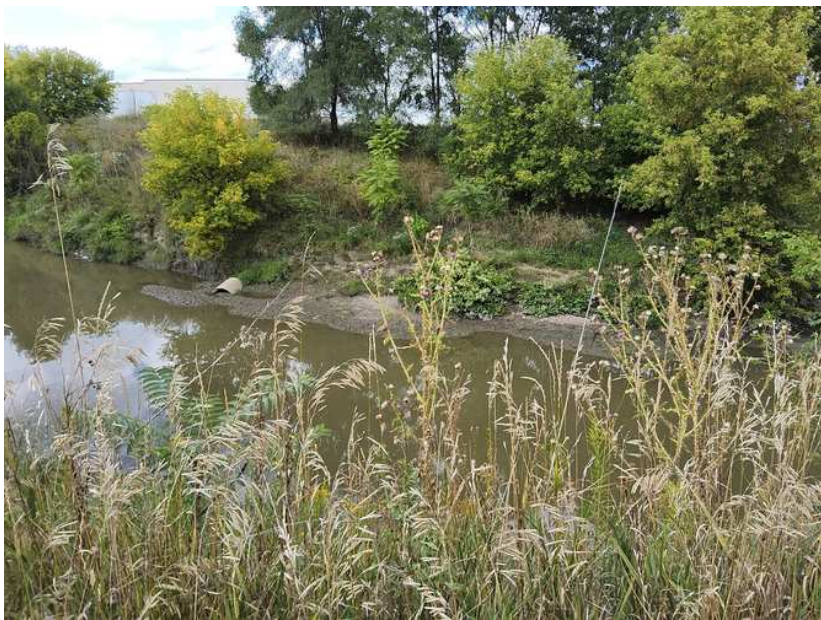
Inspect ID: 2025-10026

10026 - Minor shoaling noted. (pipe is not attached, and appears to be dumped)

Full Observation Number		2025-10026		Category		FRM Channels	
Rated Item		Shoaling (sediment deposition)		Location			
Description of Observation		Minor shoaling noted. (pipe is not attached, and appears to be dumped)					
Photo Count							
Status		Unresolved		Observation Type		Point	
Station Start				Station End			
Latitude Start	42.52505	Latitude End		Longitude Start	-83.03262	Longitude End	
Observation Date	2025-09-04

Observation Number	10026
Observation Year	2025
Full Observation Number	2025-10026
Reinspected? (Y/N)	N
Original Observation Number	
Feature	FRM Channels
Rated Item	Shoaling (sediment deposition)
Rating Code	
Rating Description	
Location	
Status	Unresolved
Monitor (Y/N)	N
Observation Type	Point
Station Start	
Station End	
GPS Start	(42.5250, -83.0326)
GPS End	
Latitude Start	42.5250
Latitude End	
Longitude Start	-83.0326
Longitude End	
Observation Date	9/4/2025
Description of Observation	Minor shoaling noted. (pipe is not attached, and appears to be dumped)
Number of Photos	undefined

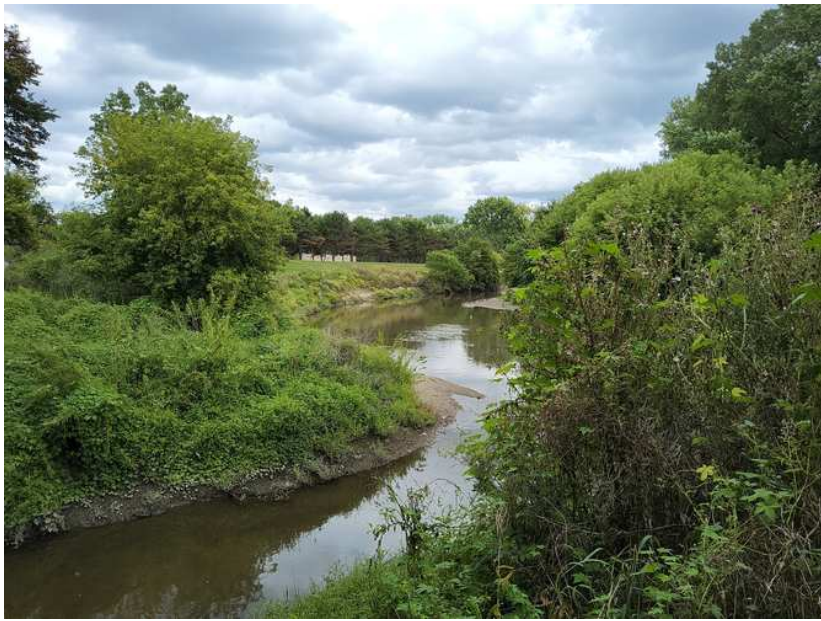
Inspect ID: 2025-10025

10025 - Typical shoaling on the inner bends and erosion on the outer bends throughout the project.

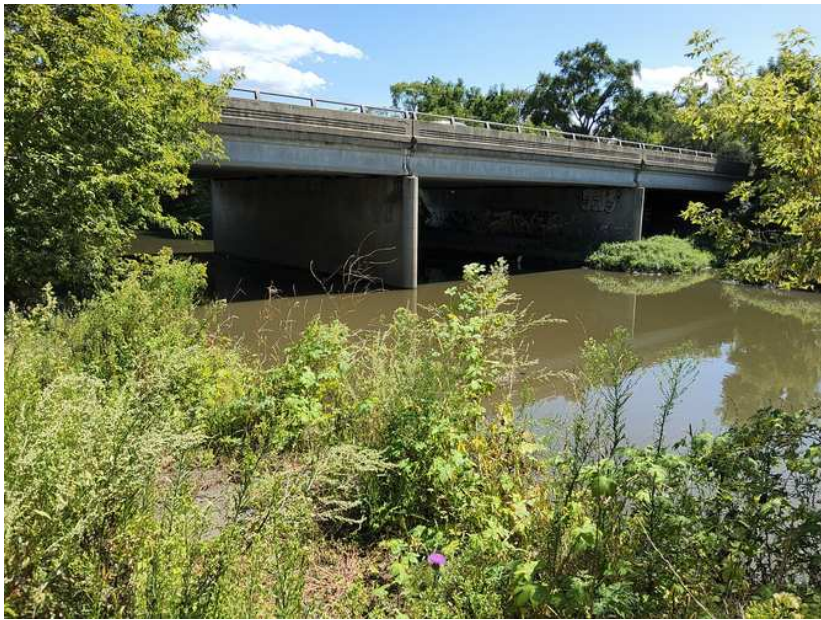
Inspect ID: 2025-10016

10016 - Shoaling noted under bridge.

Full Observation Number		2025-10016		Category		FRM Channels	
Rated Item		Shoaling (sediment deposition)		Location			
Description of Observation		Shoaling noted under bridge.					
Photo Count							
Status		Unresolved		Observation Type		Point	
Station Start				Station End			
Latitude Start	42.54984	Latitude End		Longitude Start	-82.98989	Longitude End	
Observation Date	2025-09-04

GPS Start	(42.5498, -82.9899)
GPS End	
Latitude Start	42.5498
Latitude End	
Longitude Start	-82.9899
Longitude End	
Observation Date	9/4/2025
Description of Observation	Shoaling noted under bridge.
Number of Photos	undefined

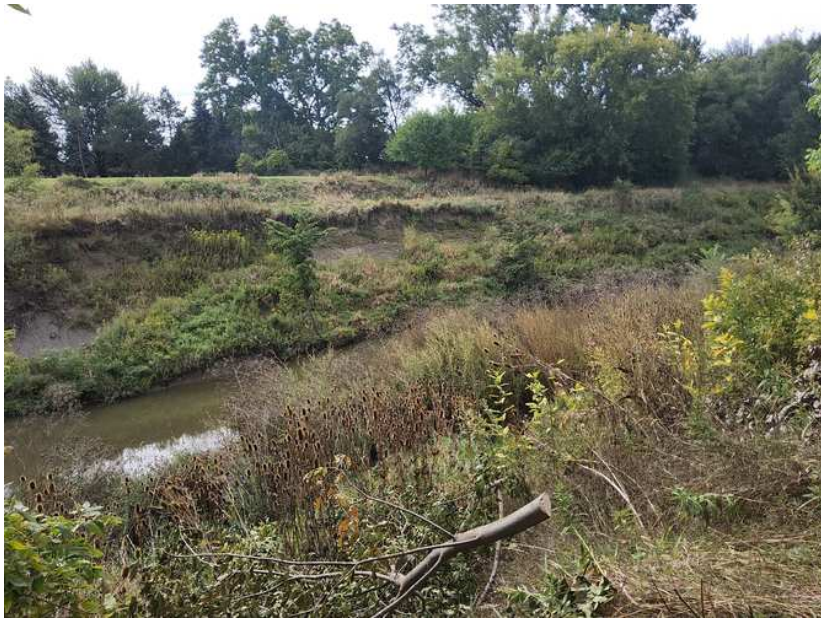
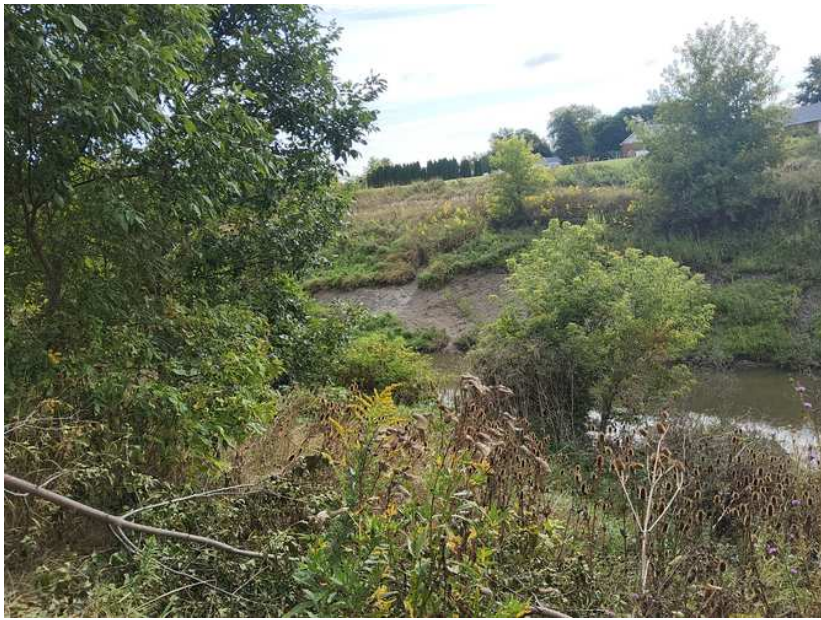
Inspect ID: 2025-10001

10001 - Recent slope failures along riverbanks.

Full Observation Number		2025-10001		Category		FRM Channels	
Rated Item		Erosion		Location			
Description of Observation		Recent slope failures along riverbanks.					
Photo Count							
Status		Unresolved		Observation Type		Point	
Station Start				Station End			
Latitude Start	42.52809	Latitude End		Longitude Start	-83.07716	Longitude End	
Observation Date	2025-09-04

Observation Number	10001
Observation Year	2025
Full Observation Number	2025-10001
Reinspected? (Y/N)	N
Original Observation Number	
Feature	FRM Channels
Rated Item	Erosion
Rating Code	
Rating Description	
Location	
Status	Unresolved
Monitor (Y/N)	N
Observation Type	Point
Station Start	
Station End	
GPS Start	(42.5281, -83.0772)
GPS End	
Latitude Start	42.5281
Latitude End	
Longitude Start	-83.0772
Longitude End	
Observation Date	9/4/2025
Description of Observation	Recent slope failures along riverbanks.
Number of Photos	undefined

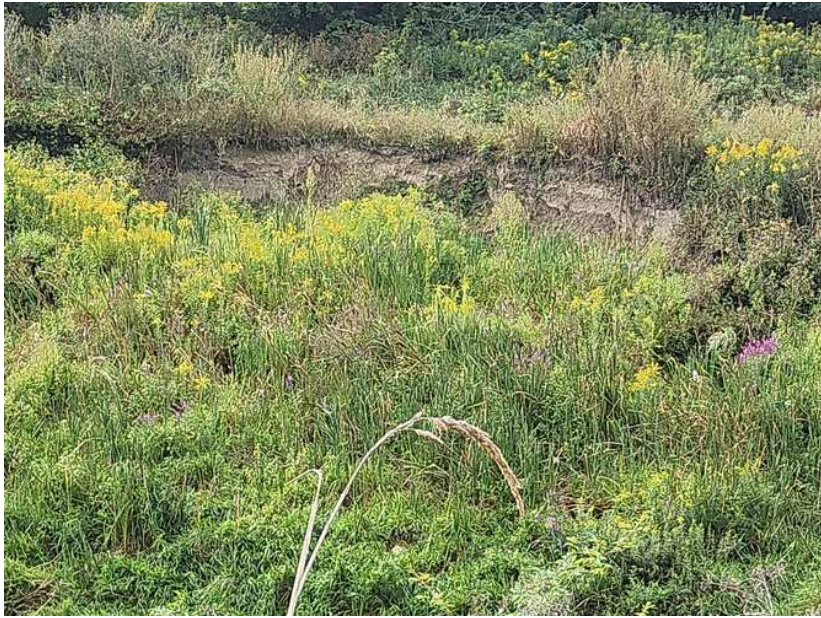
Inspect ID: 2025-10005
Rated Item: 4. Erosion
Lat/Long: 42.52898/-83.07076
Caption:
10005 - Recent slope failures noted.

Full Observation Number		2025-10005		Category		FRM Channels	
Rated Item		Erosion		Location			
Description of Observation		Recent slope failures noted.					
Photo Count							
Status		Unresolved		Observation Type		Point	
Station Start				Station End			
Latitude Start	42.52898	Latitude End		Longitude Start	-83.07076	Longitude End	
Observation Date	2025-09-04

Observation Number	10005
Observation Year	2025
Full Observation Number	2025-10005
Reinspected? (Y/N)	N
Original Observation Number	
Feature	FRM Channels
Rated Item	Erosion
Rating Code	
Rating Description	
Location	
Status	Unresolved
Monitor (Y/N)	N
Observation Type	Point
Station Start	
Station End	
GPS Start	(42.5290, -83.0708)
GPS End	
Latitude Start	42.5290
Latitude End	
Longitude Start	-83.0708
Longitude End	
Observation Date	9/4/2025
Description of Observation	Recent slope failures noted.
Number of Photos	undefined

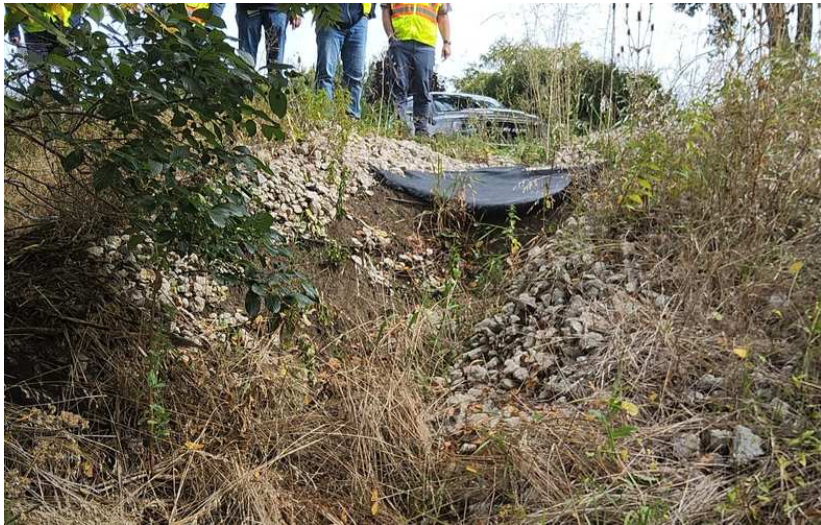
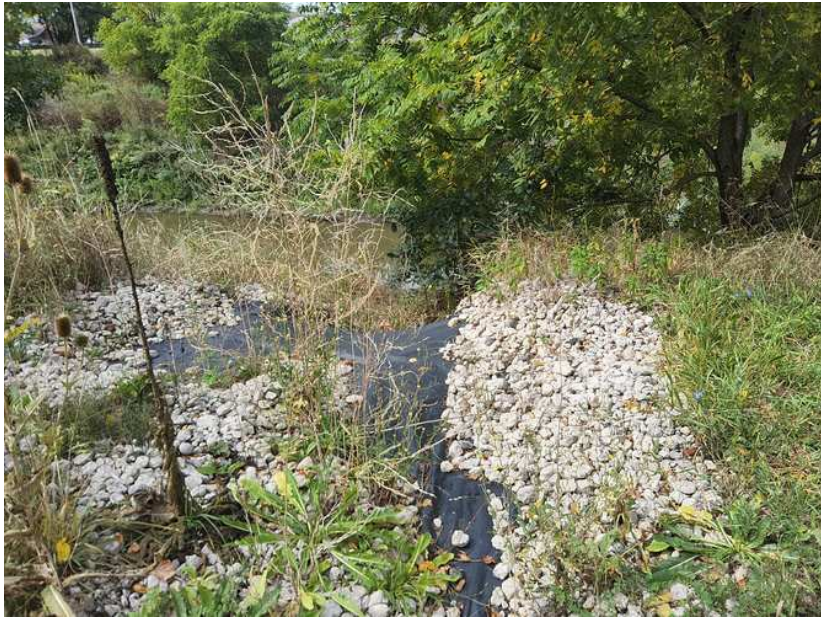
Inspect ID: 2025-10006
Rated Item: 4. Erosion
Lat/Long: 42.52918/-83.06670
Caption:
10006 - Failed erosion repair. Debris from high water event noted in trees/ brush.

10006 - Failed erosion repair. Debris from high water event noted in trees/ brush.

Full Observation Number		2025-10006		Category		FRM Channels	
Rated Item		Erosion		Location			
Description of Observation		Failed erosion repair. Debris from high water event noted in trees/ brush.					
Photo Count							
Status		Unresolved		Observation Type		Point	
Station Start				Station End			
Latitude Start	42.52918	Latitude End		Longitude Start	-83.06670	Longitude End	
Observation Date	2025-09-04

Reinspected? (Y/N)	N
Original Observation Number	
Feature	FRM Channels
Rated Item	Erosion
Rating Code	
Rating Description	
Location	
Status	Unresolved
Monitor (Y/N)	N
Observation Type	Point
Station Start	
Station End	
GPS Start	(42.5292, -83.0667)
GPS End	
Latitude Start	42.5292
Latitude End	
Longitude Start	-83.0667
Longitude End	
Observation Date	9/4/2025
Description of Observation	Failed erosion repair. Debris from high water event noted in trees/ brush.
Number of Photos	undefined

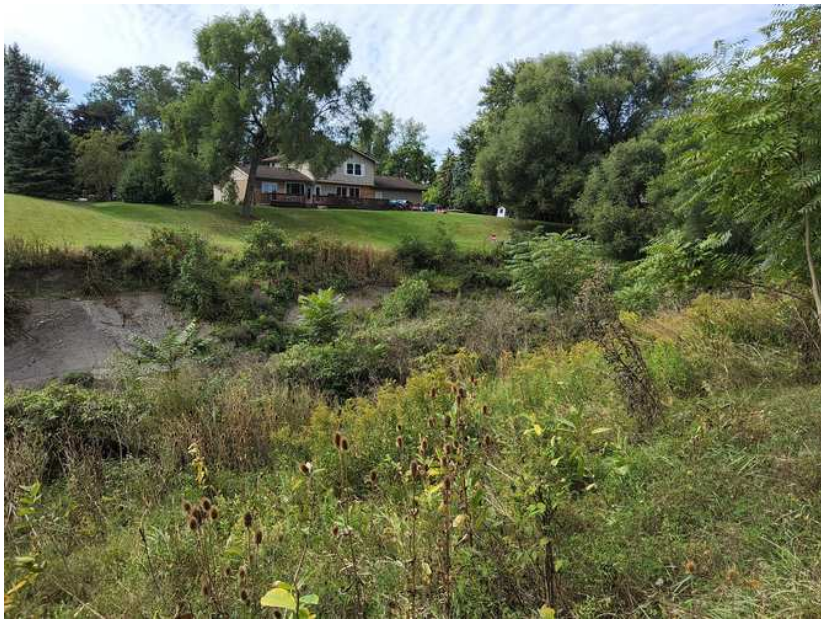
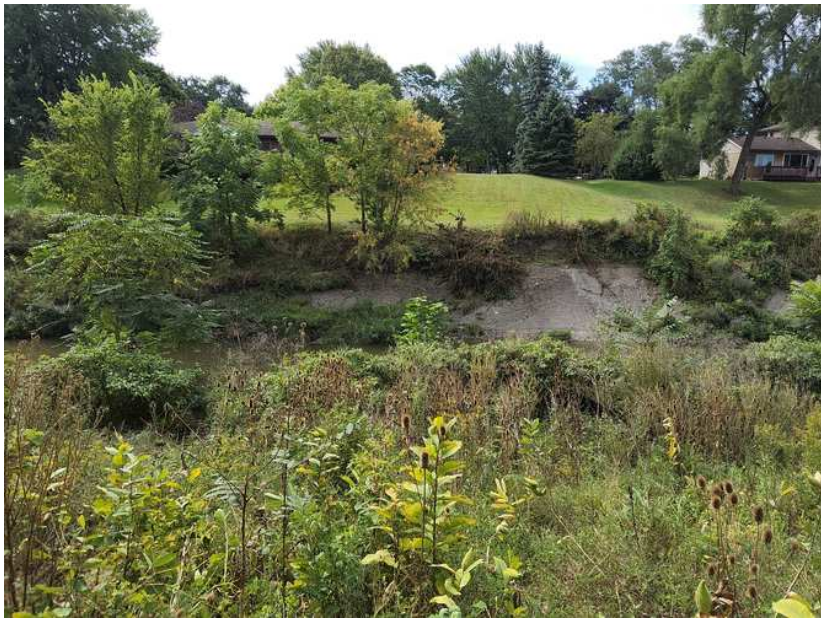
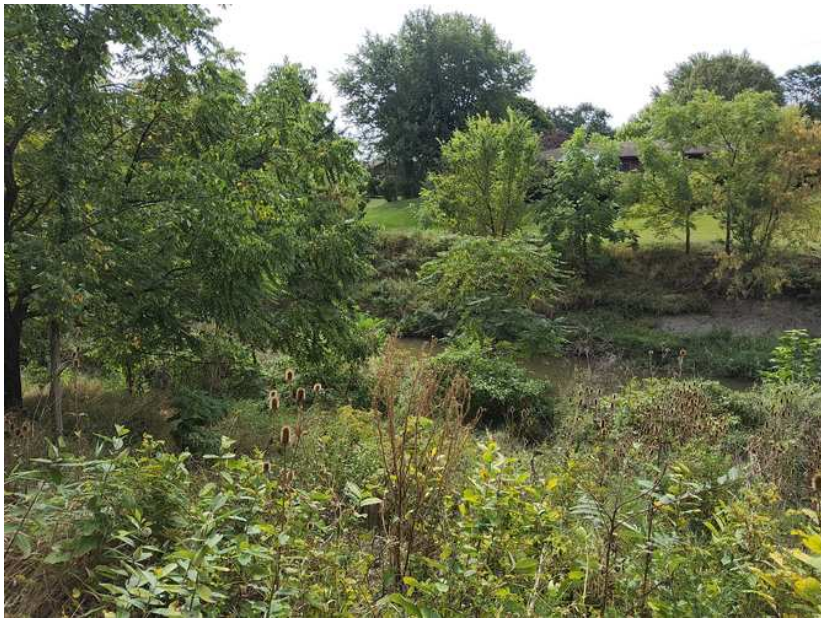
Inspect ID: 2025-10007

10007 - Slope stability issues noted that appear recent.

Full Observation Number		2025-10007		Category		FRM Channels	
Rated Item		Erosion		Location			
Description of Observation		Slope stability issues noted that appear recent.					
Photo Count							
Status		Unresolved		Observation Type		Point	
Station Start				Station End			
Latitude Start	42.52827	Latitude End		Longitude Start	-83.06515	Longitude End	
Observation Date	2025-09-04

Observation Date	9/4/2025
Description of Observation	Slope stability issues noted that appear recent.
Number of Photos	undefined

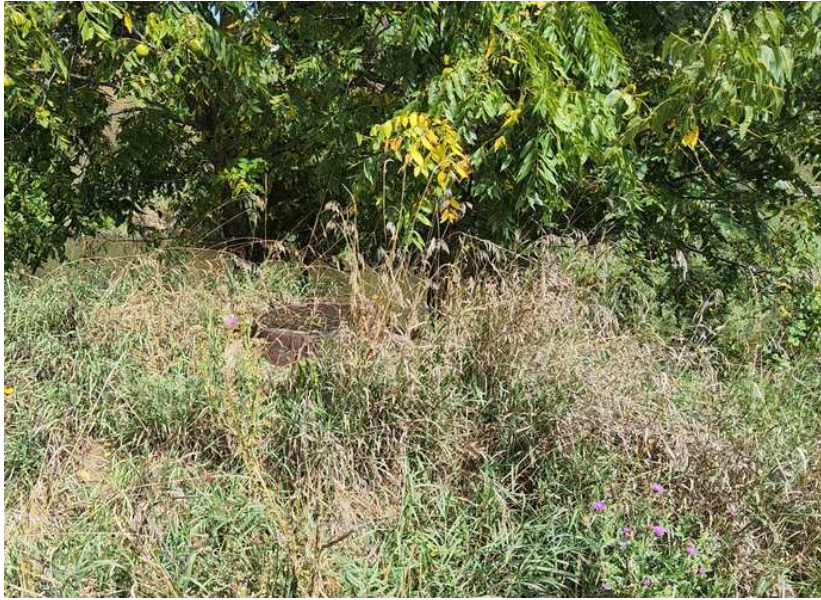
Inspect ID: 2025-10011

10011 - Minor erosion and settlement noted near storm drain.

Full Observation Number		2025-10011		Category		FRM Channels	
Rated Item		Erosion		Location		Other	
Description of Observation		Minor erosion and settlement noted near storm drain.					
Photo Count							
Status		Unresolved		Observation Type		Point	
Station Start				Station End			
Latitude Start	42.52860	Latitude End		Longitude Start	-83.05513	Longitude End	
Observation Date	2025-09-04

Observation Number	10011
Observation Year	2025
Full Observation Number	2025-10011
Reinspected? (Y/N)	N
Original Observation Number	
Feature	FRM Channels
Rated Item	Erosion
Rating Code	
Rating Description	
Location	Other
Status	Unresolved
Monitor (Y/N)	Y
Observation Type	Point
Station Start	
Station End	
GPS Start	(42.5286, -83.0551)
GPS End	
Latitude Start	42.5286
Latitude End	
Longitude Start	-83.0551
Longitude End	
Observation Date	9/4/2025
Description of Observation	Minor erosion and settlement noted near storm drain.
Number of Photos	undefined

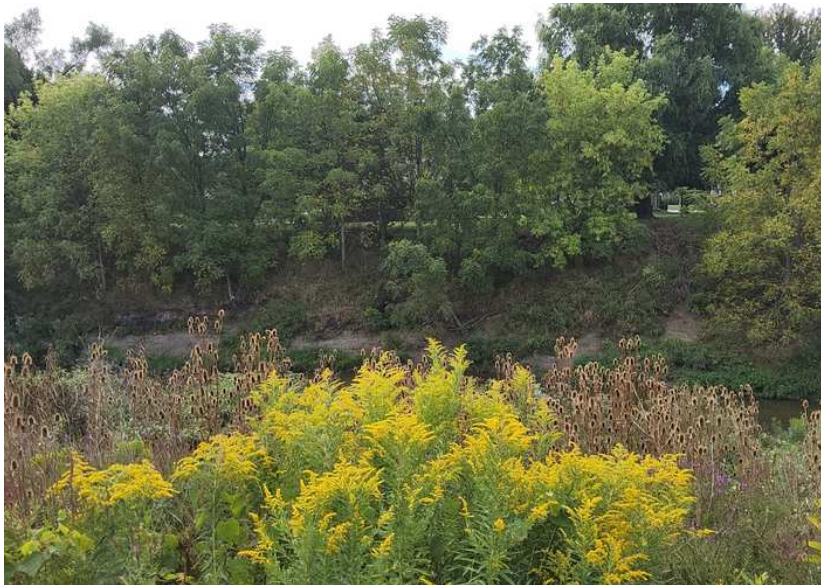
Inspect ID: 2025-10010

10010 - Slope failures/ erosion noted along riverbank.

Full Observation Number		2025-10010		Category		FRM Channels	
Rated Item		Erosion		Location			
Description of Observation		Slope failures/ erosion noted along riverbank.					
Photo Count							
Status		Unresolved		Observation Type		Point	
Station Start				Station End			
Latitude Start	42.52833	Latitude End		Longitude Start	-83.05152	Longitude End	
Observation Date	2025-09-04

Observation Number	10010
Observation Year	2025
Full Observation Number	2025-10010
Reinspected? (Y/N)	N
Original Observation Number	
Feature	FRM Channels
Rated Item	Erosion
Rating Code	
Rating Description	
Location	
Status	Unresolved
Monitor (Y/N)	N
Observation Type	Point
Station Start	
Station End	
GPS Start	(42.5283, -83.0515)
GPS End	
Latitude Start	42.5283
Latitude End	
Longitude Start	-83.0515
Longitude End	
Observation Date	9/4/2025
Description of Observation	Slope failures/ erosion noted along riverbank.
Number of Photos	undefined

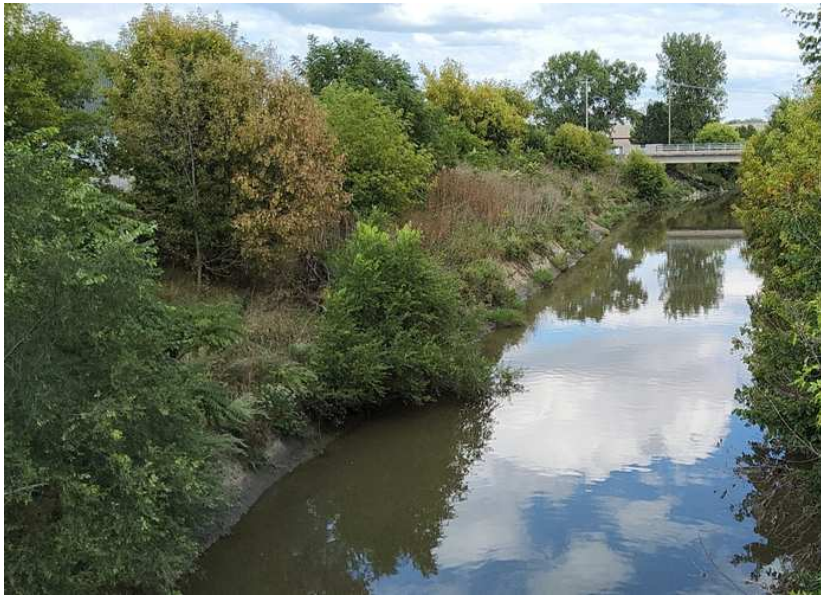
Inspect ID: 2025-10027
Rated Item: 4. Erosion
Lat/Long: 42.52639/-83.03819
Caption:
10027 - Erosion and steep slopes.

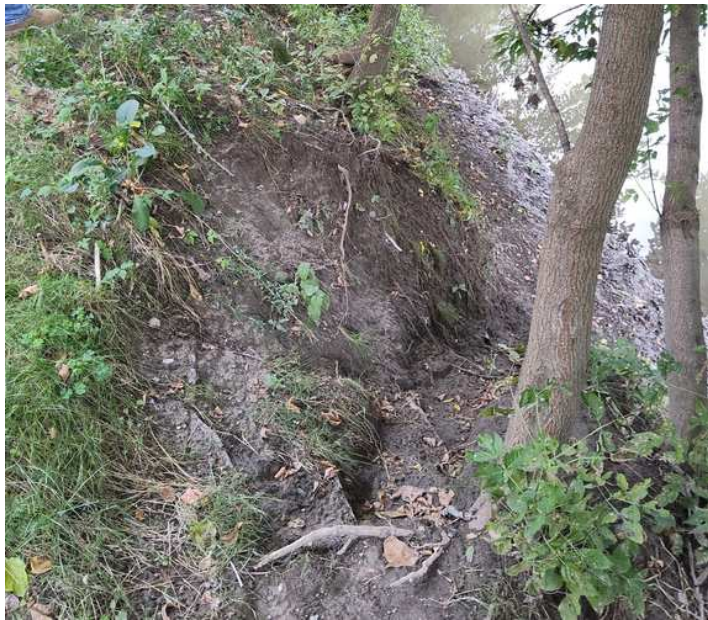
Inspect ID: 2025-10023
Rated Item: 4. Erosion
Lat/Long: 42.52974/-83.02112
Caption:
10023 - Active slope movement on steep slopes.

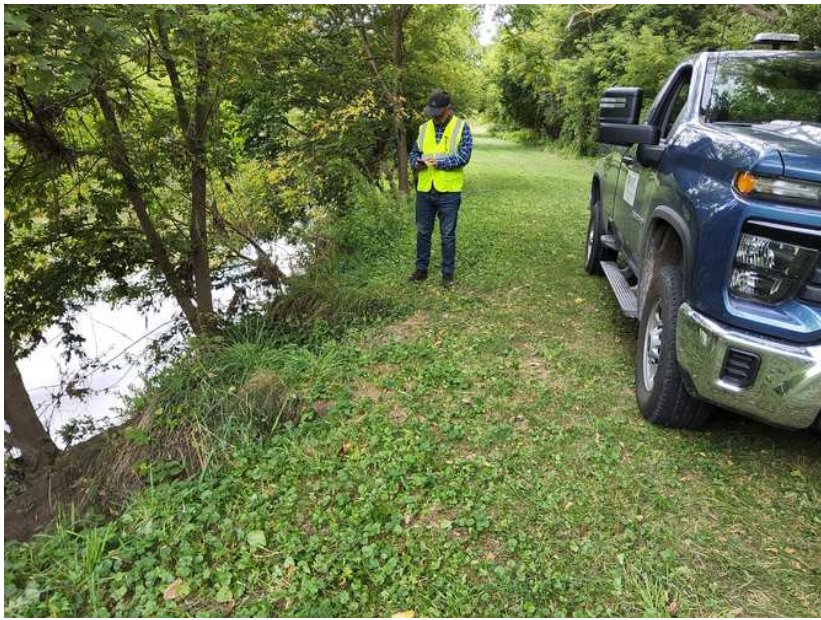
Inspect ID: 2025-10021
Rated Item: 4. Erosion
Lat/Long: 42.52995/-83.02075
Caption:
10021 - Erosion noted on slope.

Full Observation Number		2025-10021		Category		FRM Channels	
Rated Item		Erosion		Location			
Description of Observation		Erosion noted on slope.					
Photo Count							
Status		Unresolved		Observation Type		Point	
Station Start				Station End			
Latitude Start	42.52995	Latitude End		Longitude Start	-83.02075	Longitude End	
Observation Date	2025-09-04

Observation Number	10021
Observation Year	2025
Full Observation Number	2025-10021
Reinspected? (Y/N)	N
Original Observation Number	
Feature	FRM Channels
Rated Item	Erosion
Rating Code	
Rating Description	
Location	
Status	Unresolved
Monitor (Y/N)	N
Observation Type	Point
Station Start	
Station End	
GPS Start	(42.5300, -83.0207)
GPS End	
Latitude Start	42.5300
Latitude End	
Longitude Start	-83.0207
Longitude End	
Observation Date	9/4/2025
Description of Observation	Erosion noted on slope.
Number of Photos	undefined

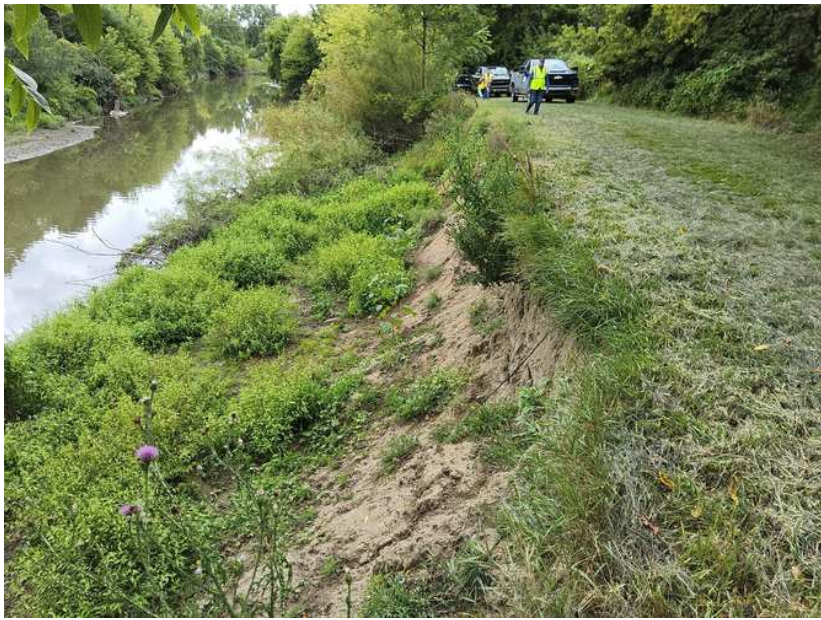
Inspect ID: 2025-10024
Rated Item: 4. Erosion
Lat/Long: 42.53034/-83.02074
Caption:
10024 - Slope has failed in this area, slumped material noted.

Full Observation Number		2025-10024		Category		FRM Channels	
Rated Item		Erosion		Location			
Description of Observation		Slope has failed in this area, slumped material noted.					
Photo Count							
Status		Unresolved		Observation Type		Point	
Station Start				Station End			
Latitude Start	42.53034	Latitude End		Longitude Start	-83.02074	Longitude End	
Observation Date	2025-09-04

Monitor (Y/N)	N
Observation Type	Point
Station Start	
Station End	
GPS Start	(42.5303, -83.0207)
GPS End	
Latitude Start	42.5303
Latitude End	
Longitude Start	-83.0207
Longitude End	
Observation Date	9/4/2025
Description of Observation	Slope has failed in this area, slumped material noted.
Number of Photos	undefined

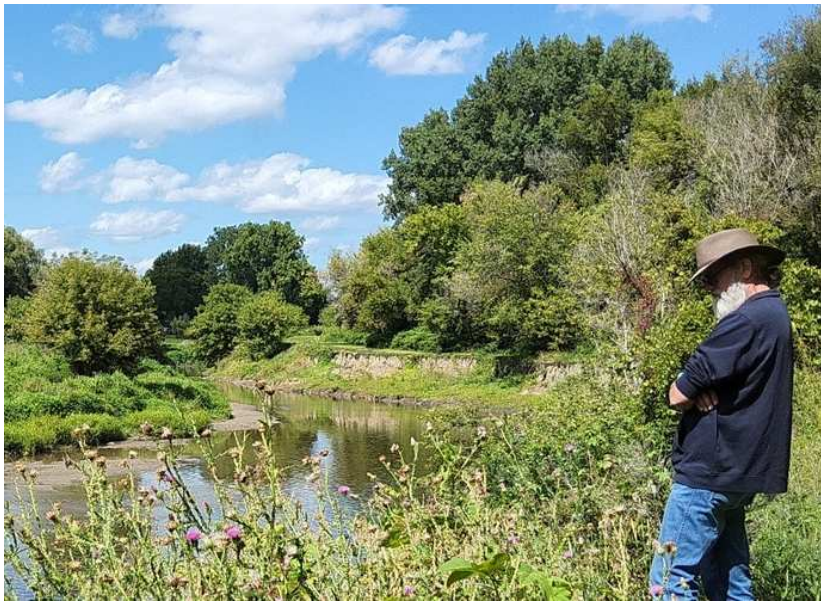
Inspect ID: 2025-10019
Rated Item: 4. Erosion
Lat/Long: 42.53211/-83.01538
Caption:
10019 - Erosion along riverbank.

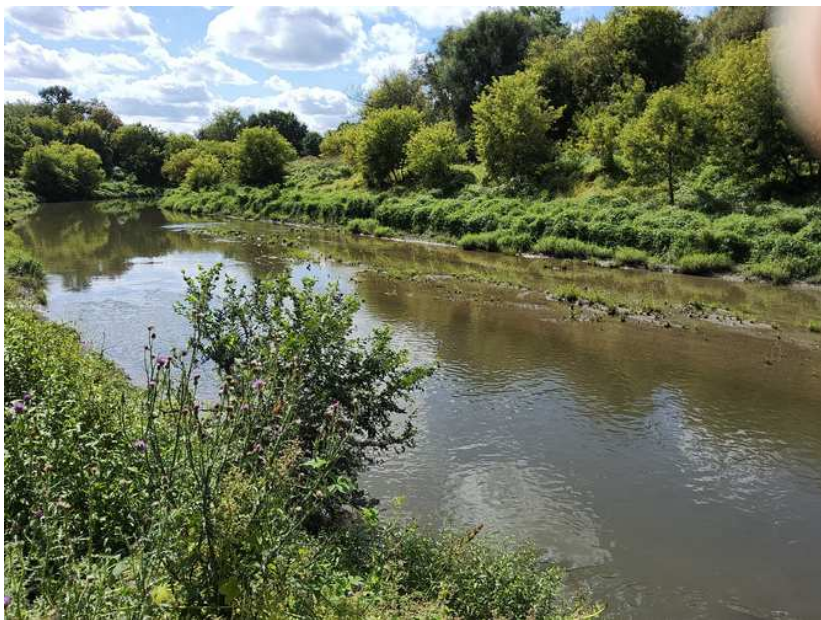
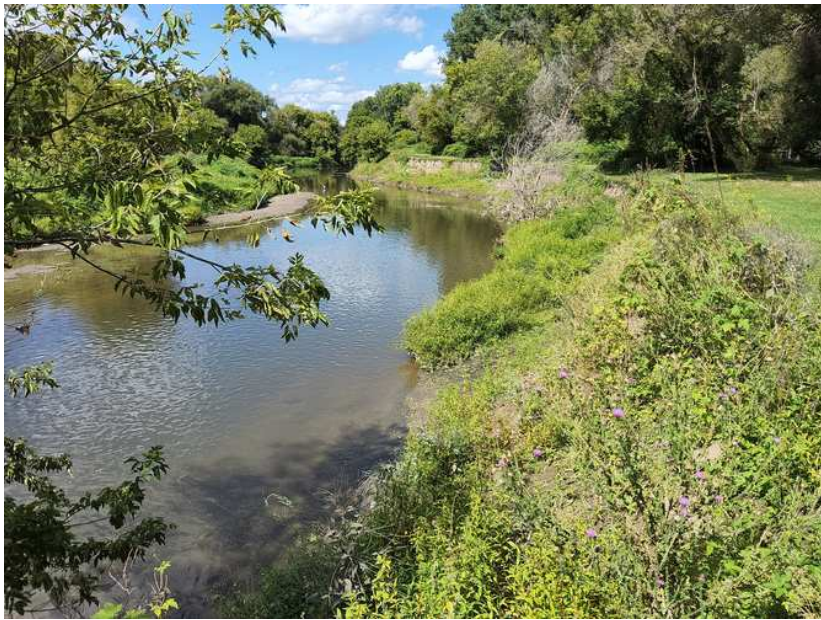
Inspect ID: 2025-10020
Rated Item: 4. Erosion
Lat/Long: 42.53224/-83.01526
Caption:
10020 - Unstable slopes and shallow/ shoaled in channel.

10020 - Unstable slopes and shallow/ shoaled in channel.

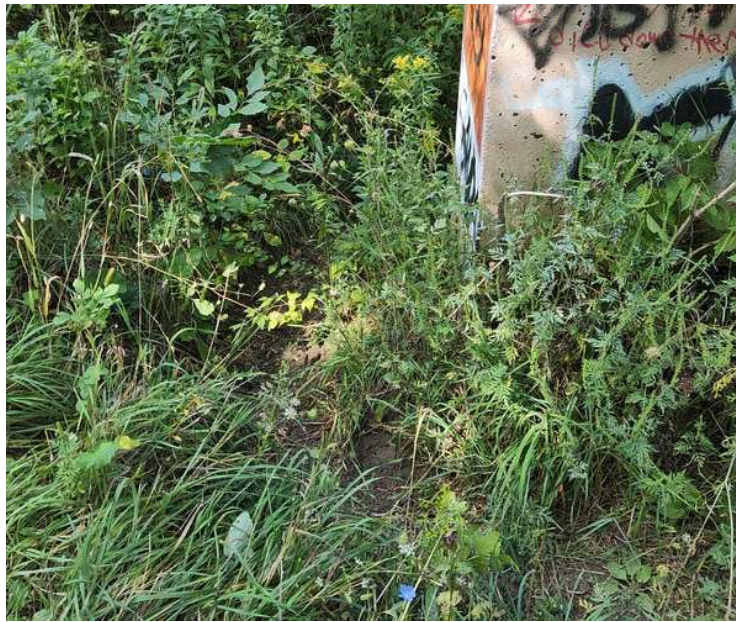
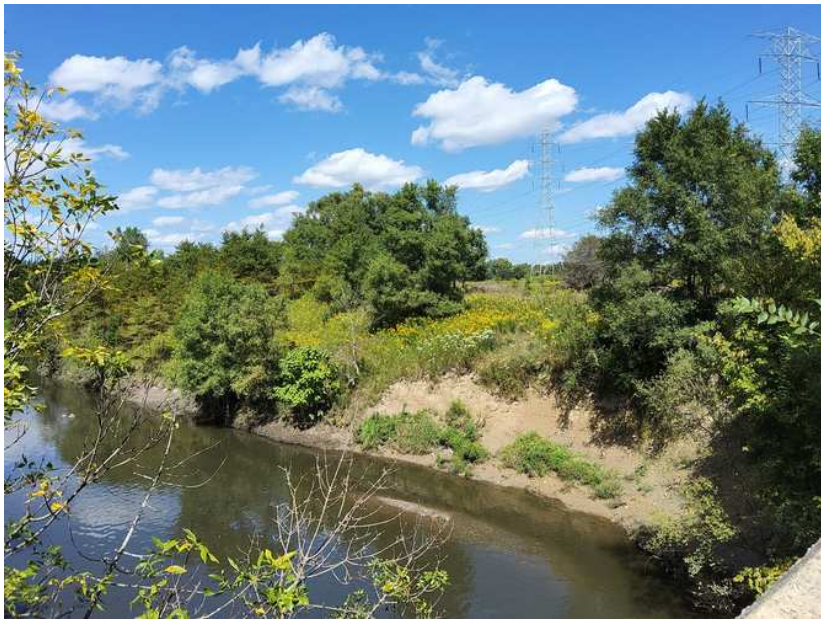
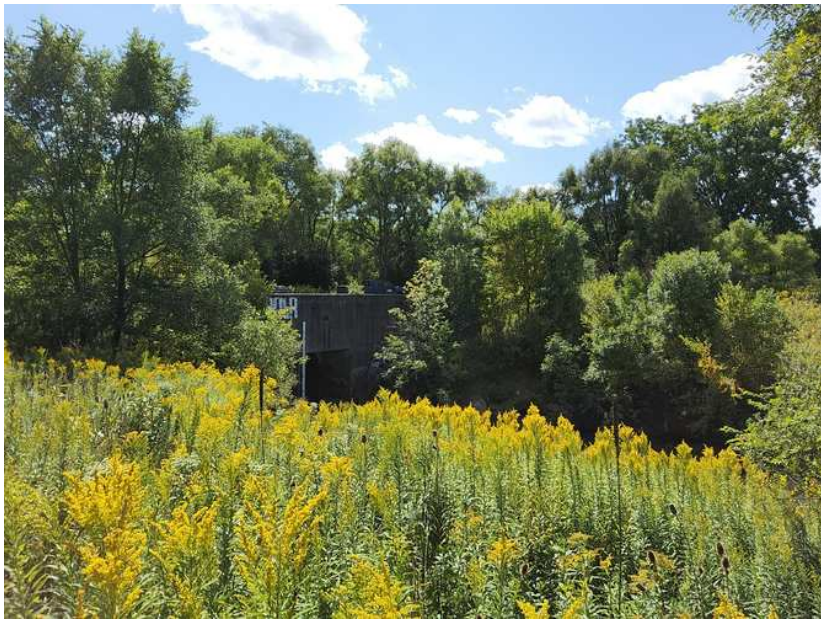
10017 - Erosion along bank at outfall

Inspect ID: 2025-10017
Rated Item: 4. Erosion
Lat/Long: 42.53912/-82.99956
Caption:
10017 - Erosion along bank at outfall

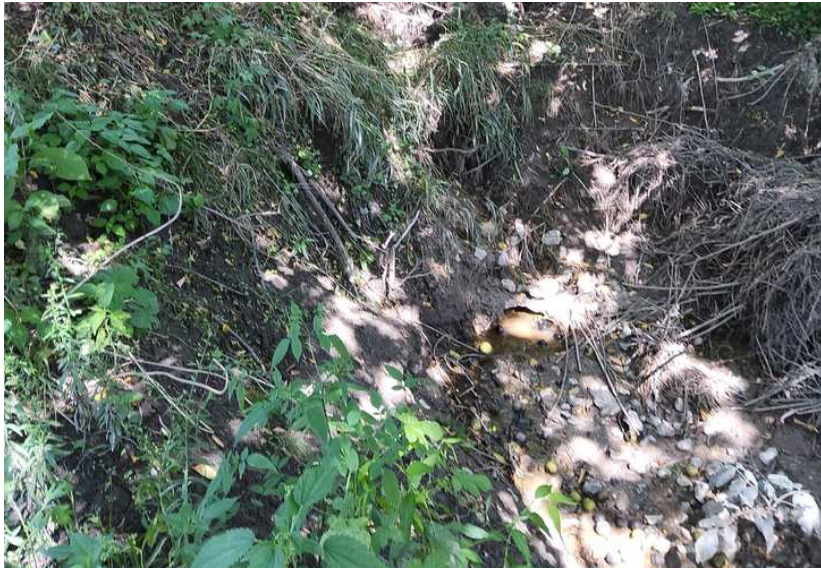
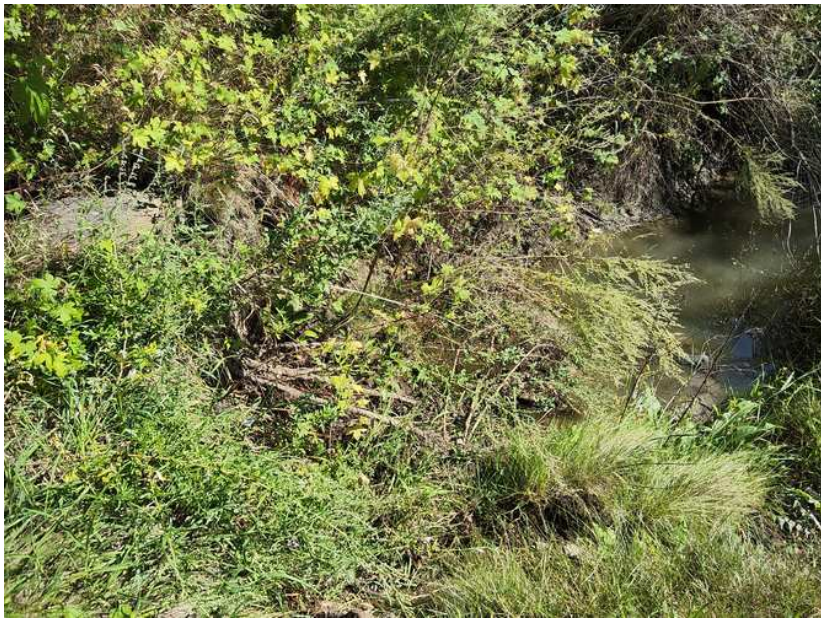
Inspect ID: 2025-10015
Rated Item: 4. Erosion
Lat/Long: 42.54995/-82.98982
Caption:
10015 - Pipe collapse noted.

Full Observation Number		2025-10015		Category		FRM Channels	
Rated Item		Erosion		Location			
Description of Observation		Pipe collapse noted.					
Photo Count							
Status		Unresolved		Observation Type		Point	
Station Start				Station End			
Latitude Start	42.54995	Latitude End		Longitude Start	-82.98982	Longitude End	
Observation Date	2025-09-04

Observation Number	10015
Observation Year	2025
Full Observation Number	2025-10015
Reinspected? (Y/N)	N
Original Observation Number	
Feature	FRM Channels
Rated Item	Erosion
Rating Code	
Rating Description	
Location	
Status	Unresolved
Monitor (Y/N)	N
Observation Type	Point
Station Start	
Station End	
GPS Start	(42.5499, -82.9898)
GPS End	
Latitude Start	42.5499
Latitude End	
Longitude Start	-82.9898
Longitude End	
Observation Date	9/4/2025
Description of Observation	Pipe collapse noted.
Number of Photos	undefined

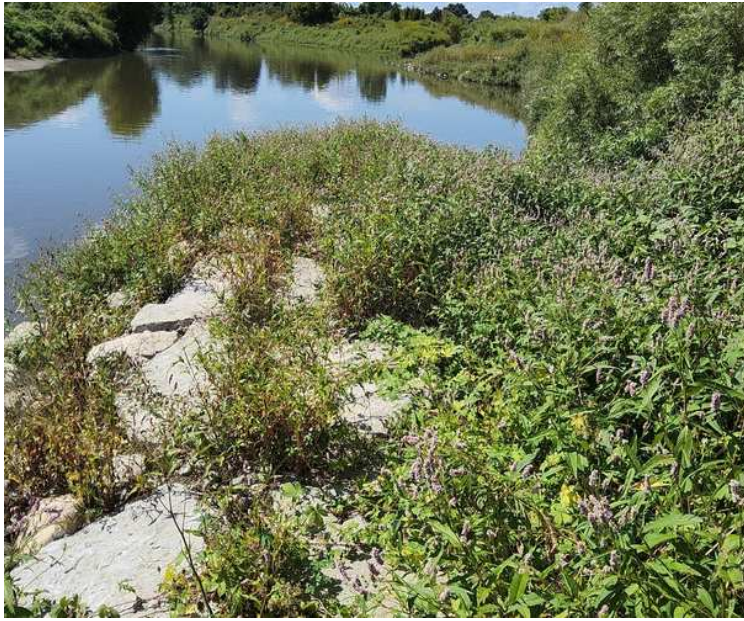
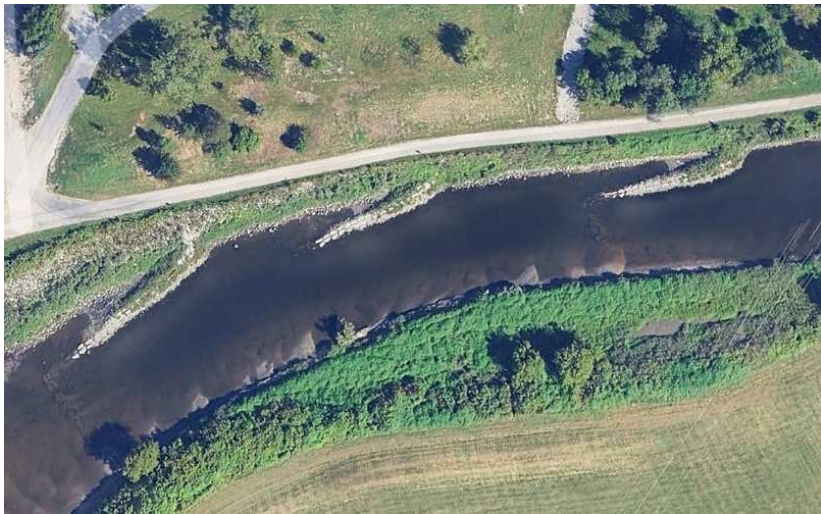
Inspect ID: 2025-10013

10013 - J-hooks constructed by sponsor. No performance issues noted.

Full Observation Number		2025-10013		Category		FRM Channels	
Rated Item		Erosion		Location			
Description of Observation		J-hooks constructed by sponsor. No performance issues noted.					
Photo Count							
Status		Unresolved		Observation Type		Point	
Station Start				Station End			
Latitude Start	42.56127	Latitude End		Longitude Start	-82.97895	Longitude End	
Observation Date	2025-09-04

Observation Number	10013
Observation Year	2025
Full Observation Number	2025-10013
Reinspected? (Y/N)	N
Original Observation Number	
Feature	FRM Channels
Rated Item	Erosion
Rating Code	
Rating Description	
Location	
Status	Unresolved
Monitor (Y/N)	N
Observation Type	Point
Station Start	
Station End	
GPS Start	(42.5613, -82.9790)
GPS End	
Latitude Start	42.5613
Latitude End	
Longitude Start	-82.9790
Longitude End	
Observation Date	9/4/2025
Description of Observation	J-hooks constructed by sponsor. No performance issues noted.
Number of Photos	undefined

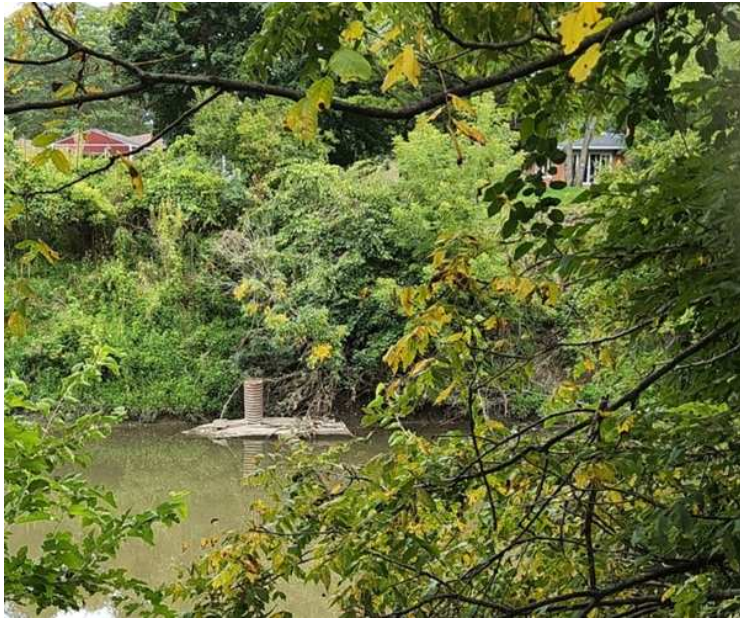
Inspect ID: 2025-10022

10022 - Outfall has completely failed and fallen into the river.

Full Observation Number		2025-10022		Category		FRM Channels	
Rated Item		Concrete Surfaces		Location			
Description of Observation		Outfall has completely failed and fallen into the river.					
Photo Count							
Status		Unresolved		Observation Type		Point	
Station Start				Station End			
Latitude Start	42.52986	Latitude End		Longitude Start	-83.02110	Longitude End	
Observation Date	2025-09-04

Latitude End	
Longitude Start	-83.0211
Longitude End	
Observation Date	9/4/2025
Description of Observation	Outfall has completely failed and fallen into the river.
Number of Photos	undefined

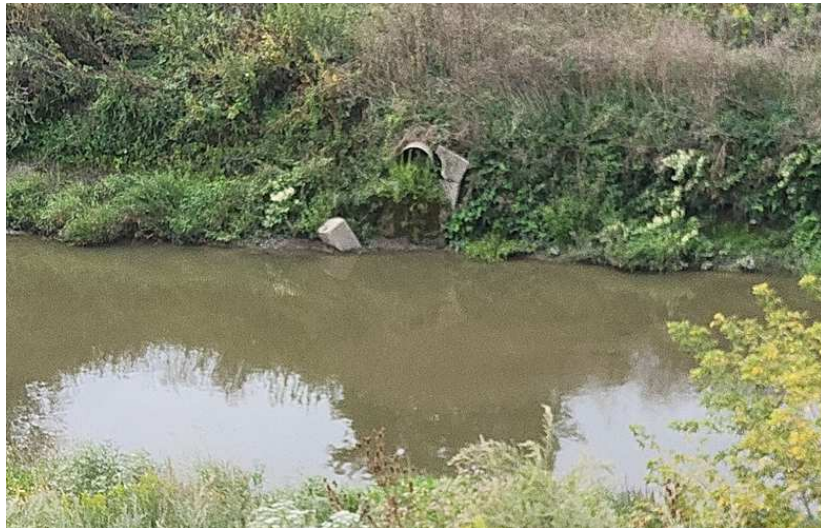
Inspect ID: 2025-10004

10004 - Outfall and headwalls in poor condition.

Full Observation Number		2025-10004		Category		FRM Channels	
Rated Item		Tilting, Sliding or Settlement of Concrete Structures		Location			
Description of Observation		Outfall and headwalls in poor condition.					
Photo Count							
Status		Unresolved		Observation Type		Point	
Station Start				Station End			
Latitude Start	42.52929	Latitude End		Longitude Start	-83.07223	Longitude End	
Observation Date	2025-09-04

Status	Unresolved
Monitor (Y/N)	N
Observation Type	Point
Station Start	
Station End	
GPS Start	(42.5293, -83.0722)
GPS End	
Latitude Start	42.5293
Latitude End	
Longitude Start	-83.0722
Longitude End	
Observation Date	9/4/2025
Description of Observation	Outfall and headwalls in poor condition.
Number of Photos	undefined

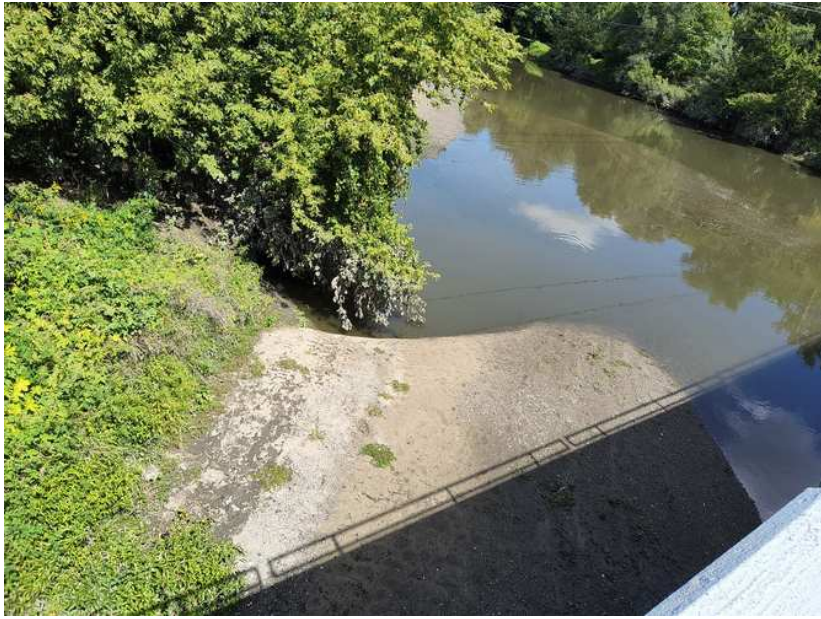
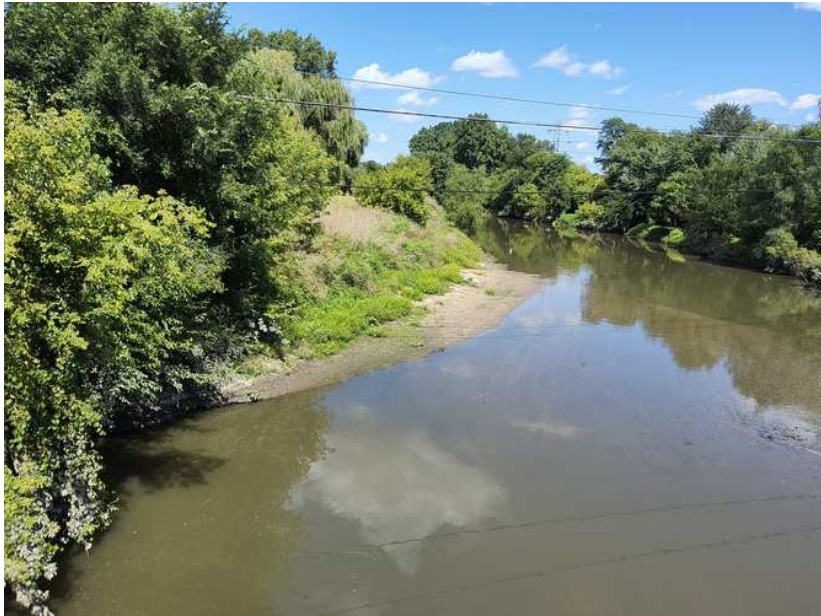
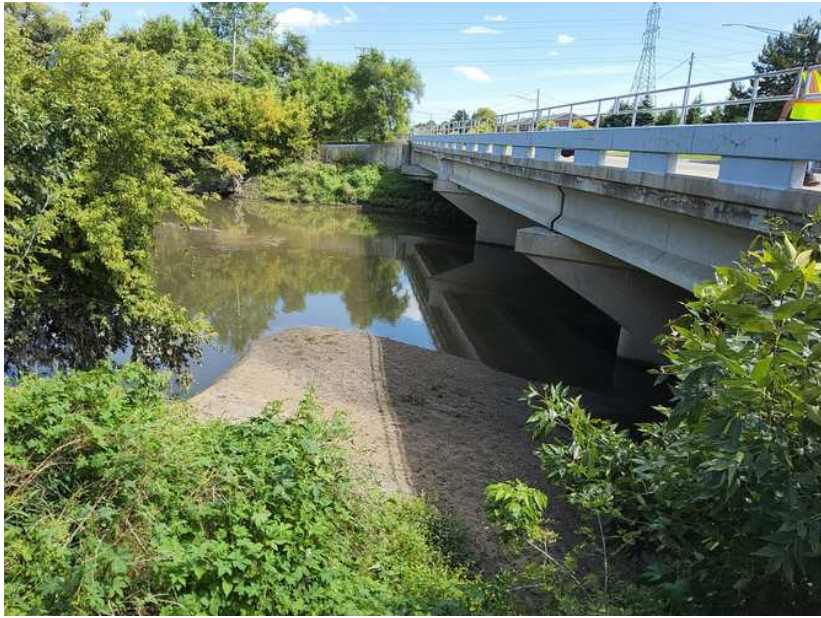
Inspect ID: 2025-10014

10014 - heavy shoaling at Moravian Drive Bridge
