AGENDA

Red Run Intercounty Drain Drainage Board Macomb and Oakland Counties

December 17, 2025 – 10:30 a.m.

Summary of Site Visit: *[Summarize pertinent discussions with sponsor regarding levee conditions, O&M activities, etc. and describe notable observations or changed conditions since the last site visit or inspection]*

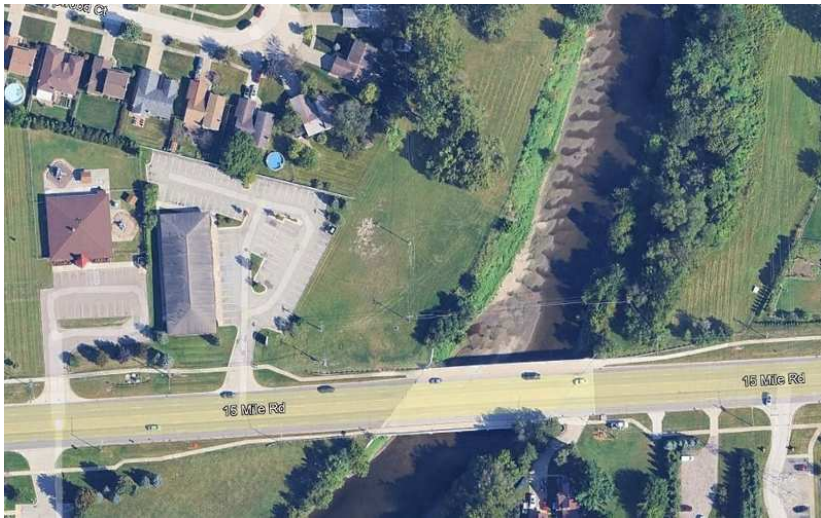
Inspect ID: 2025-10014

10014 - heavy shoaling at Moravian Drive Bridge

Rated Item: 9. Flap Gates / Flap Valves / Pinch Valves
